Product : CRT monitor

Bulletin No. : 01-C/M-E0050

Model : AQ17HS/IS, AQ19IS/MS

SUBJECT : DY-Wire foaming change

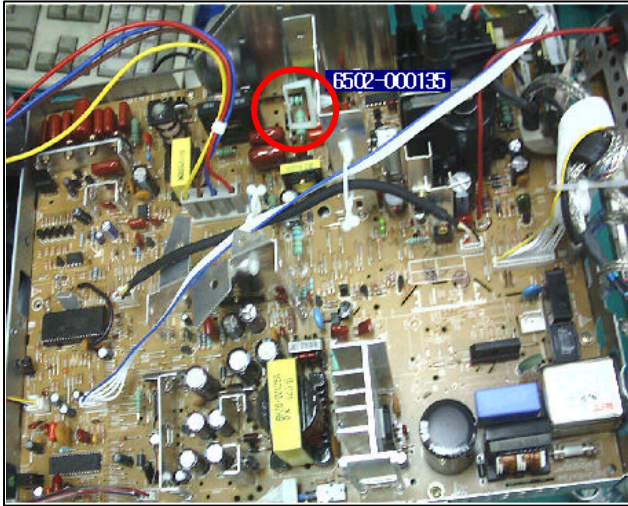
BEFORE

Background : DY-wire forming of AQ17HS/IS & AQ19IS/MS model have design problem.
 DY-wire can be touch with sharp edge of high voltage FET heat sink. this case, calbe could peel off.
 This peel off cause spark and some other accident.
 Samsung changed DY-wire clamp shape and forming method from Nov.01,2001

Solution When repairing upper monitor model check wire condition.(if produced before Nov.2001)
 If wire and clamp shape is old version please change clamp and wire forming method.
 (refer to attached pictures)
