Product : Color monitor
Model : CFX1577 Model
Buyer : All subsidiaries

Bulletin No. 98-MON-E0001
Bulletin Date 1998.1.20
ECN Date : 1998.1.19

SUBJECT : CFX-1577, Countermeasure for centering focus problem

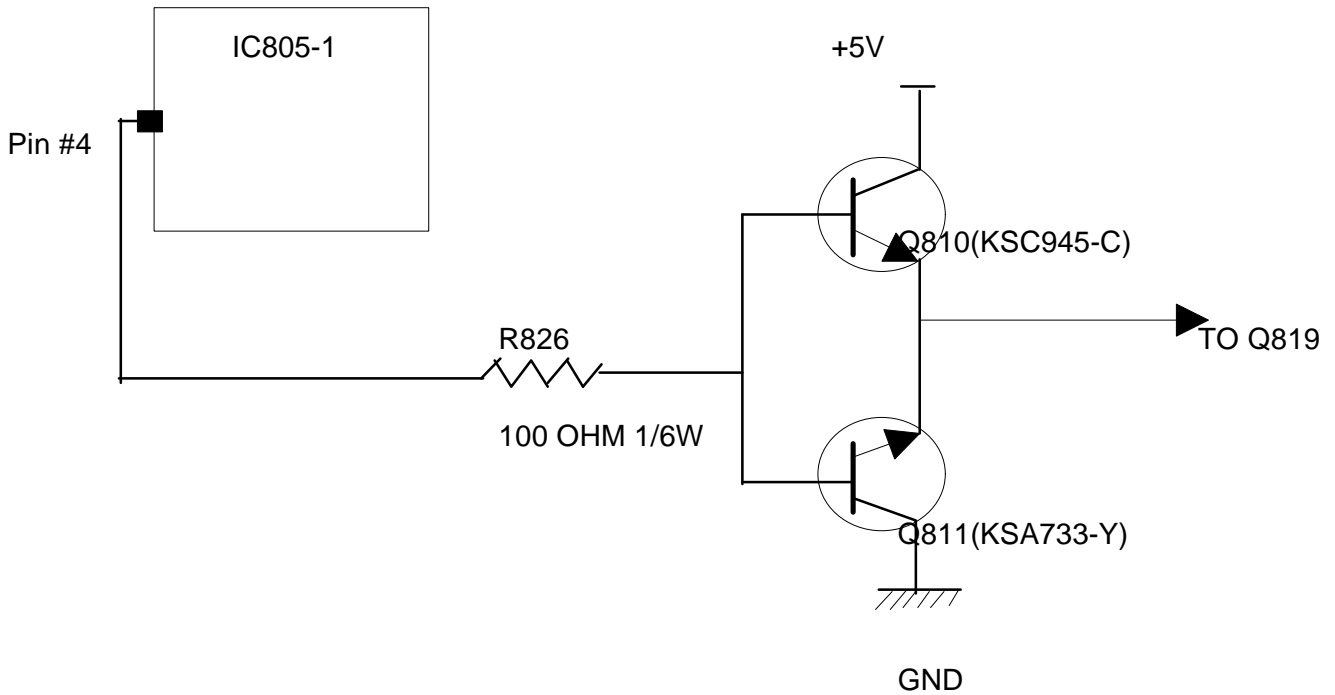
Before schematic Diagram

Background : Sometime screen flickering or center focus problem at field.
 (Symptom)

Cause : Internal core of L801(Focus Trans Coil)is saturated due to over current of suspend mode.
