Product: CRT MONITOR
Model: AN19J*, AN19L*, CA19J*

Bulletin No.: MON02-016 (02-C/M-E0102)
Bulletin Date: December 10, 2002
ECN Date: December 10, 2002

SUBJECT: DPMS Noise

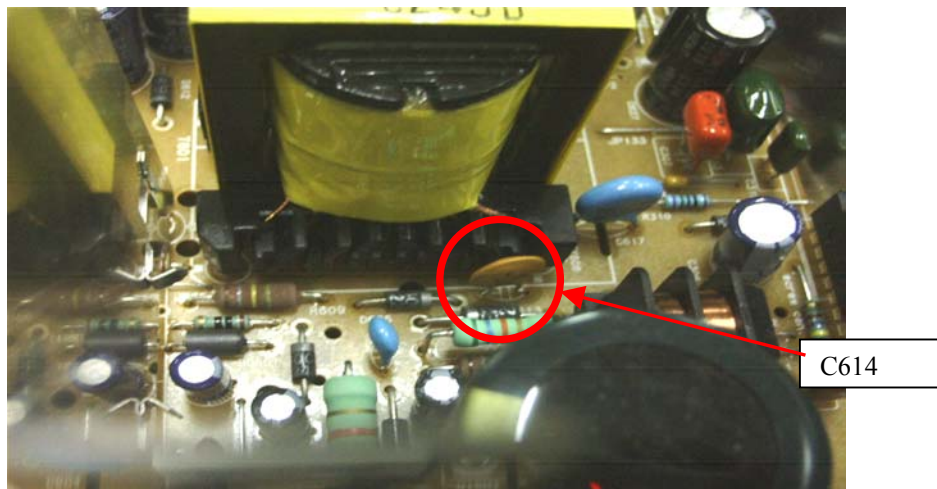
Background: A whistling sound occurs when the monitor goes into DPMS mode.

Cause: The current of IC601 is abnormal during the off mode causing T601 to vibrate.

Solution: Change the value of capacitor C614 from 10nf to 2.2nf.
