SERVICE TIP	
PRODUCT:	DLP PROJECTION TV
TIP NUMBER:	ASC20040802003
Posting Date:	08/02/2004
MODELS:	HL-P4663, HL-P5063, HL-P5663, and HL-P6163
Chassis	L3

SUBJECT: Vertical lines in the picture

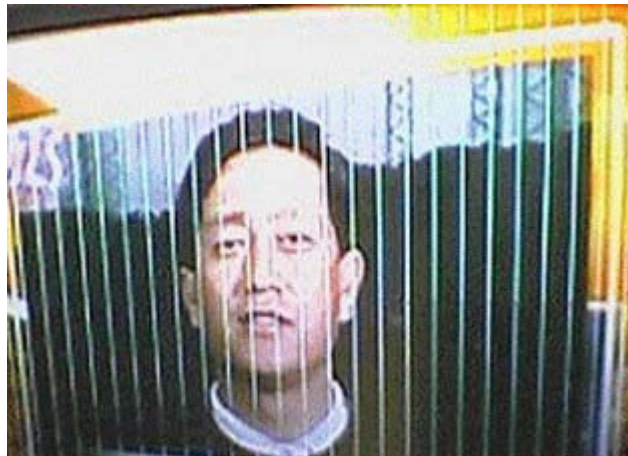
Figure 1

SYMPTOM: When unit is turned on picture will have vertical lines across the entire screen. These can be white or black lines, see Figure 1.

REPAIR: Replace the DMD board. Then perform the Tilt Adjustment listed on the next page

Parts Used- BP96-00678A

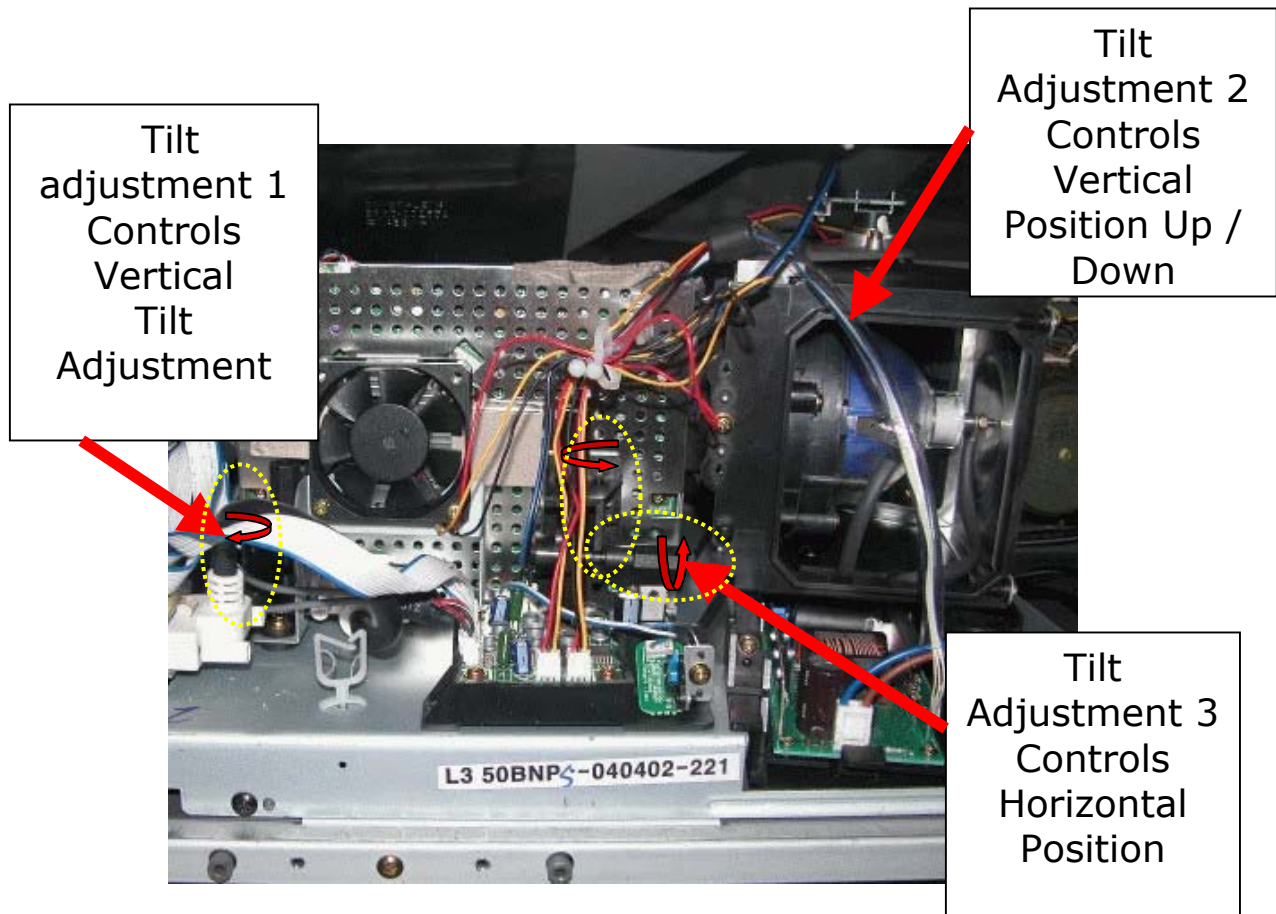
1. Use a signal generator to apply a crosshatch pattern to the unit
2. Secure the safety switch on the right of the unit with tape so the unit can be operated with the rear cover off.
3. Monitor the display while rotating the three adjustment screws (figure 2) clockwise and counterclockwise until the pattern is level.
4. Verify the tilt on screen before replacing the cabinet back.
