car stereo Service Bulletin No.81

Model: CDX-A10

Subject: Disc Magazine Jams In The Unit
During Eject

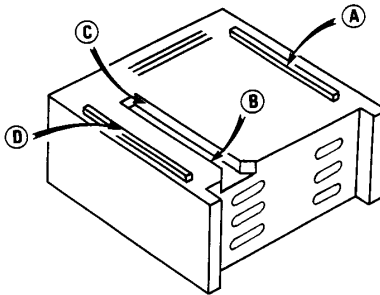
When using the XA-10B disc magazine in the unit, the magazine may get stuck during eject.

Bottom view of XA-10B

Lubricate the guide slots on the XA-10B magazine using the following procedure:

1. Lubricate the four guide slots (A-D) shown in the diagram with a small amount of silicon oil (P/N 7-661-012-15) using an applicator (cotton swab, etc).
2. Leave as is for one minute.
3. Wipe the applied oil with a cloth.

Note: The XA-10 (grey type) already has a dry lubricant applied.
