**Car Stereo
Service Bulletin**

Model: CDX-A30

No. 143

Subject: High Pitch Noise During Playback

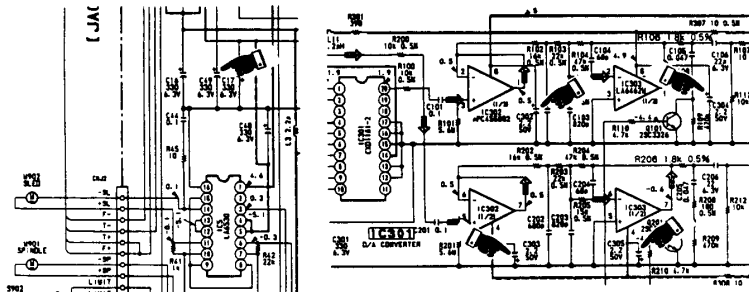
At high volume levels, a high pitch noise can be heard between tracks and during quiet passages. This noise may be difficult to hear at low or normal volume settings.

Cause:
The characteristics of the low-pass filter has changed.

Solution: Replace the chemical capacitors C49, C302, C303, C304, and C305 with the parts listed below:

| Ref. No. | Former Part | New Part | |
|---|---|---|---|
| C49 | 3300 μ F/6.3V | 330 μ F/6.3V | 1-124-442-00 |
| C302, C303, C304, C305 | 100 μ F/6.3V | 2.2 μ F/50V | 1-124-257-00 |
