Car Stereo  
Service Bulletin

**Model:** EX-R400, XR-300

**No. 167**

**Subject:** Flashing Display

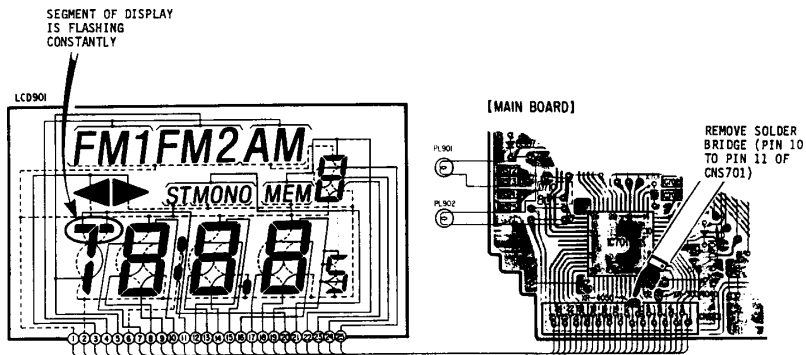
Segment of display is flashing constantly.

**Solution:** Remove solder bridge on Pins 10 and 11 of CNS701.
