**Car Stereo
Service Bulletin**

Model: CDX-7520/-7540/-7560/-7580

No. 197

Subject: Unit Mutes While Making Turns And
During Braking

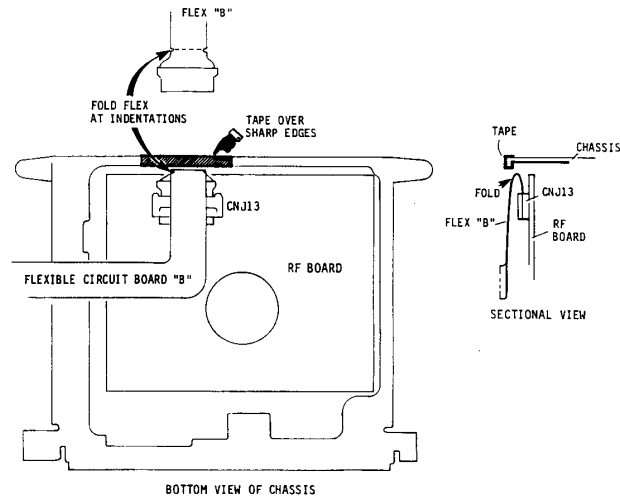
If the unit mutes while making turns or during braking, perform the following procedure:

- Solution:**
1. Install non-woven tape (9mm x 25mm) on the chassis (main) assembly (as shown in the drawing below).
 2. Fold flexible circuit board "B" at indentations towards the inside of the deck.

Description	Part Number
Non-Woven Fabric Tape (10cm x 20cm)	3-831-441-11
