Car Stereo
Service Bulletin

Model: XM-3040/-3520

No. 200R1

Subject: Protection Turns On

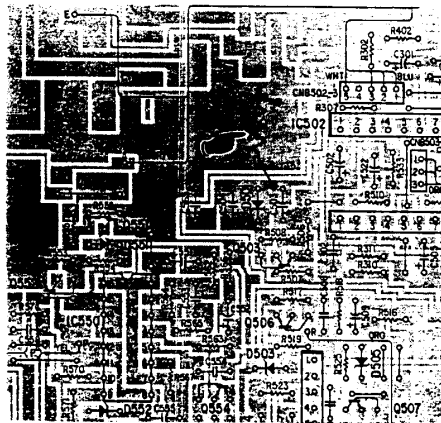
XM-3040

The Protection Circuit is activated when the amplifier is connected to other equipment or when it is tested alone.

Solution: Add the following resistor between the two grounds on the "Main" Board as shown below:

Description	Part Number
470 Ohms 1 W resistor	1-215-867-00
