Car Stereo Service Bulletin

Model: CDX-4090

No. 380

Subject: No Audio.

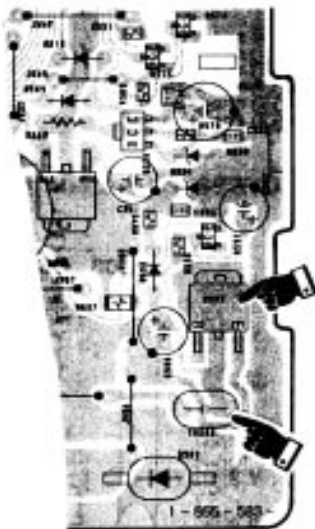
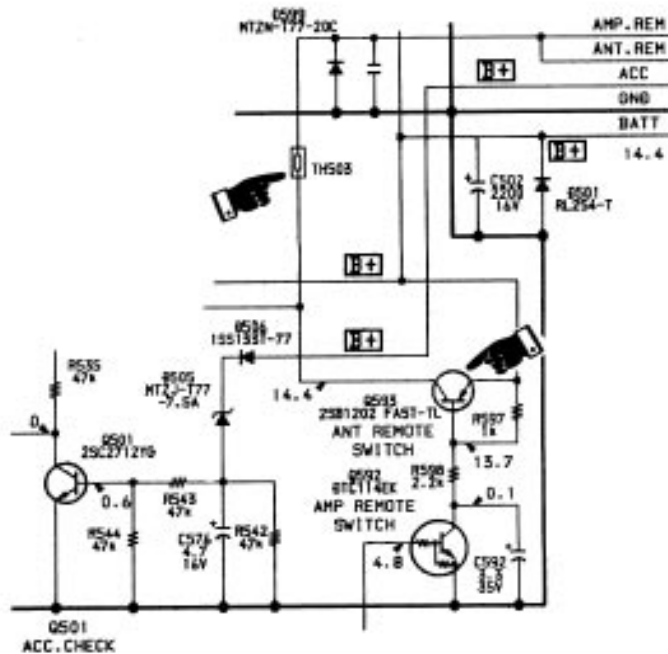
The unit has no audio regardless of the source. In some instances the STEREO indicator on the display may always be illuminated. This problem may be caused by Q593 being defective.

Check Q-593, and if found to be defective replace it. Also, change TH503 to a different type which offers greater protection against damage to Q593.

REF	FORMER		NEW	
	DESCRIPTION	PART NUMBER	DESCRIPTION	PART NUMBER
Q593	TRANSISTOR, 2SB1202FAST	8-729-822-84	SAME	SAME
TH503	THERMISTOR, 2.2 OHM	1-809-148-21	THERMISTOR, 2.0 OHM	1-809-842-21
