Car Stereo Service Bulletin

Model: XM-C2000

No. 385

Subject: Service Manual Correction: IC902 Pinouts.

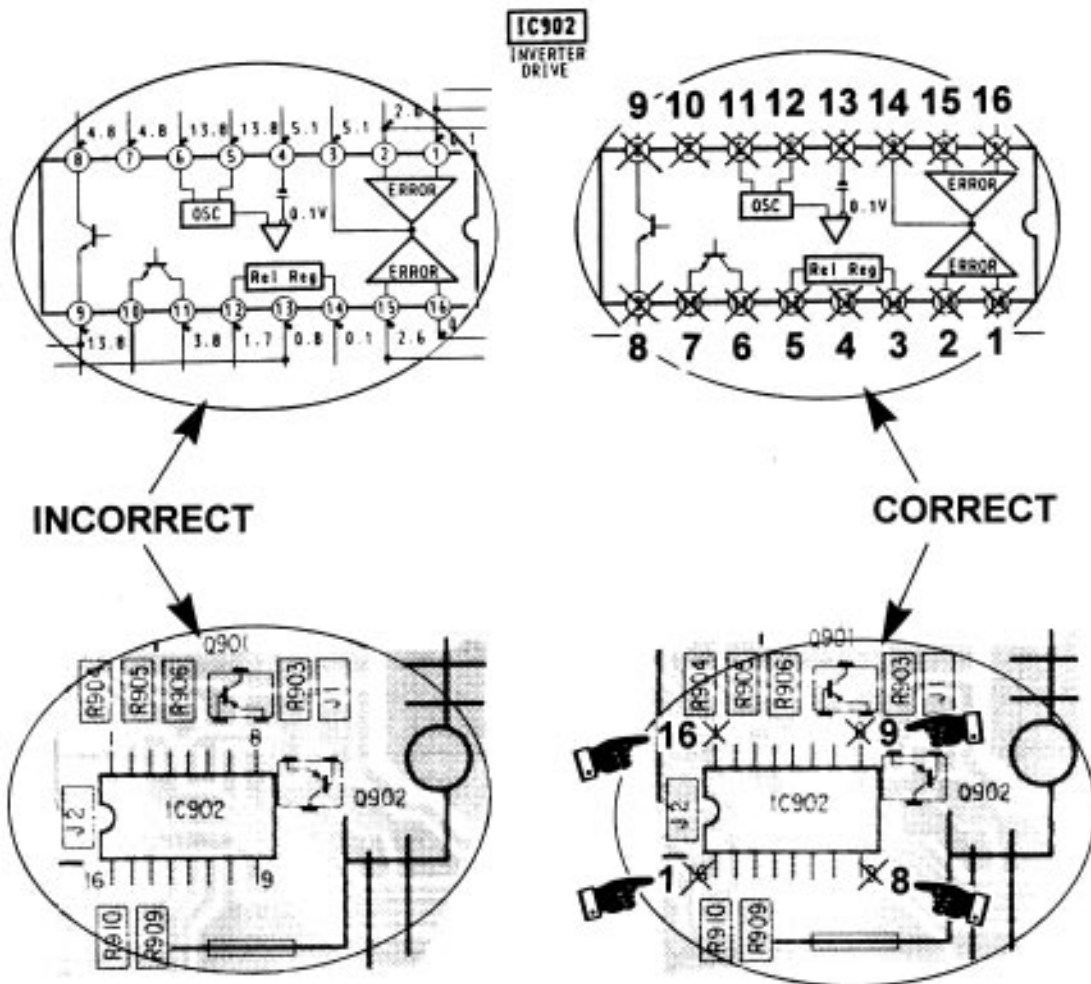
(**) The pinouts shown for IC902 in the service manual are incorrect.

Solution: Please make the following correction to your service manual.
