# Car Stereo Service Bulletin

**Model:** XR-C210

**No.** 386

**Subject:** Preventing Recurring Damage To Sub-panel.

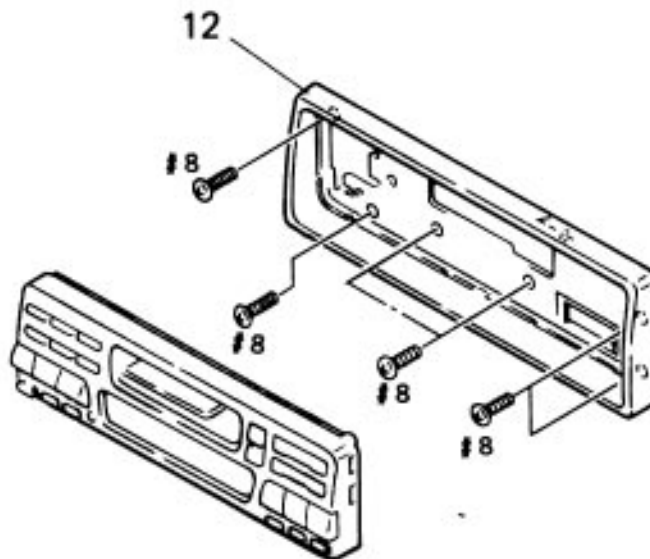
Replacing a broken sub-panel without also replacing the mounting screws with a different type may lead to recurring damage to the sub-panel.

When replacing a broken sub-panel, also replace the mounting screws shown in the drawing.

REF	FORMER		NEW	
	DESCRIPTION	PART NUMBER	DESCRIPTION	PART NUMBER
12	PANEL, SUB	3-916-373-01	SAME	SAME
#8	SCREW, +PTT 2.6 X 6 (S)	7-621-773-95	SCREW, +B, 2.6 X 6	3-932-551-01
