Service Bulletin Car Stereo

Model: CDX-C810DSP

No. 419

Subject: PICKUP IS HEARD THROUGH SUBWOOFER

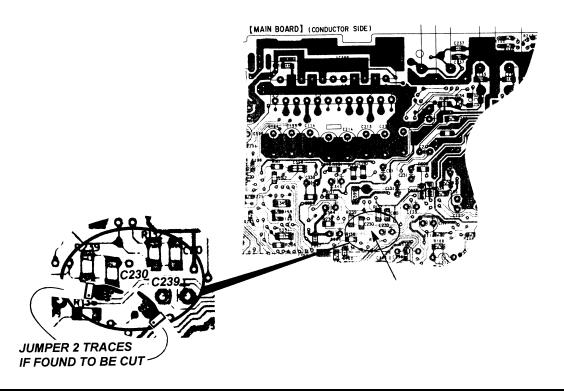
Audible pickup can be heard through the subwoofer outputs. When the unit is tapped or shocked by vibration you can hear a thumping noise coming from the subwoofer outputs.

There are two traces between C230 and C239. (see diagram below) If these traces have been cut, they need to be jumpered back for a connection. Jumper the two cut traces with thin wires on the solderside of the main board. After cut traces are reconnected, test unit by tapping chassis and monitoring subwoofer outputs.
