Service Bulletin Car Stereo

Model: CDX-2100, CDX-2160, CDX-3100, CDX-3160, CDX-4160, CDX-C410, CDX-C460, CDX-C510, CDX-C560, CDX-C610, CDX-C660, CDX-C710, CDX-C760, CDX-C810DSP, CDX-C860, EXCD-21, EXCD-31, EXCD-206

No. 424R1

Subject: INCOMPATIBILITY INFORMATION FOR CD CHASSIS

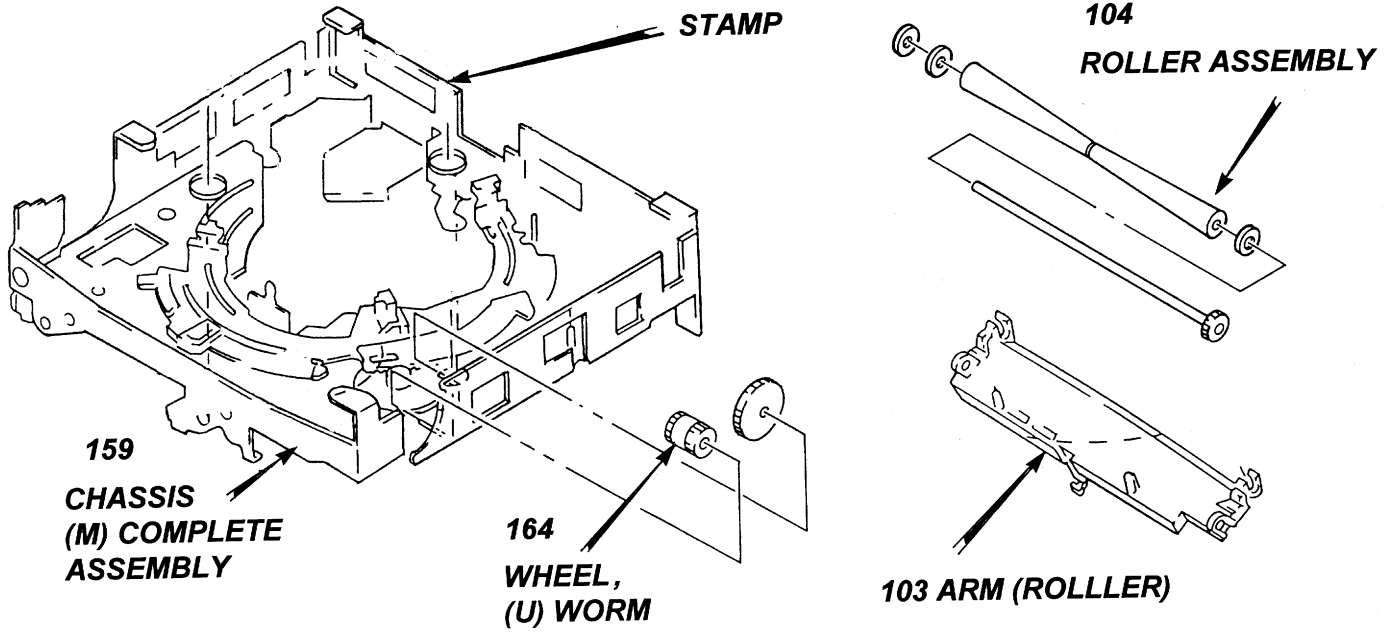
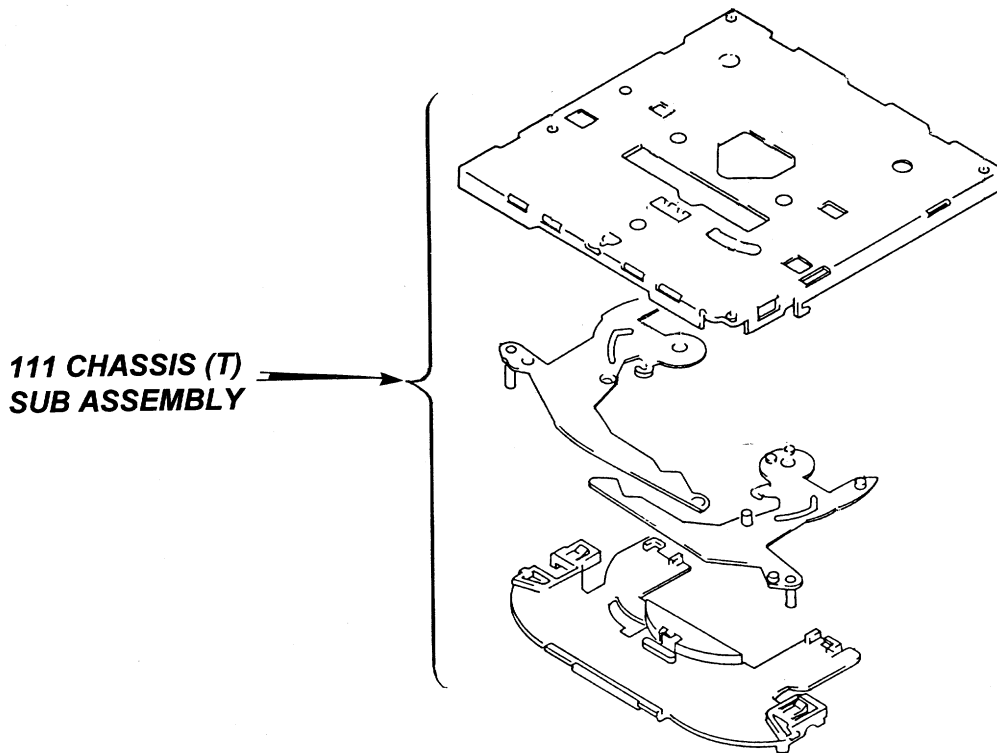
Applicable Serial Number Range: Look at the number stamp on the Mech. Deck. A number whose **last** 2 digits are greater than 38 should have new parts already. If it is below 38 it is using former parts.

Example: 6x241**37**- former part, 6x241**38**- new part
