Car Stereo Service Bulletin

Model: XR-7280

No. 207

Subject: A.M.S. Does Not Work and/or Cross-Talk

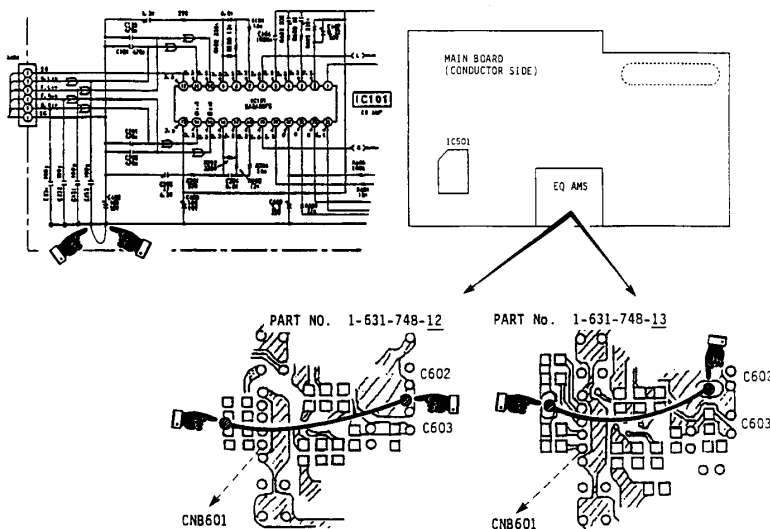
A.M.S. does not work and/or cross-talk is heard between left and right channels of tape deck.

Add a ground wire to "EQ A.M.S. Block" of main board. Mounting of the ground wire is dependent upon the part number printed on the main board.
