Car Stereo Service Bulletin

Model: CDX-7560/7580/5040/7540/7520/5180/
5080/4040/6020/ U8000/R77/R79/ EXCD-40
Subject: MD Board Screws Come Loose

No. 241

Date: June 30, 1992

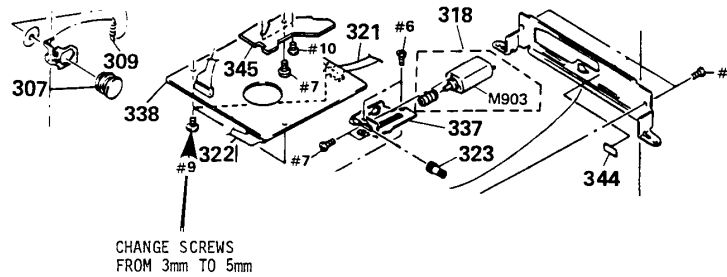
Symptom:
(11) MD Board screws come loose, shorting out parts on the Main Board. The usual customer complaint is "DEAD".

Solution: Perform the following modification:
Change the MD Board screws from 3mm to 5mm.

DESCRIPTION		PART NUMBER
FORMER	NEW	
SCREW, 2 X 3	SCREW, 2 X 5	7-621-771-06
