Car Stereo  
Service Bulletin

**Model:** CDX-5180

**No.248**

**Subject:** Ticking Noise During Quiet Passages Or  
Between Tracks On Disc

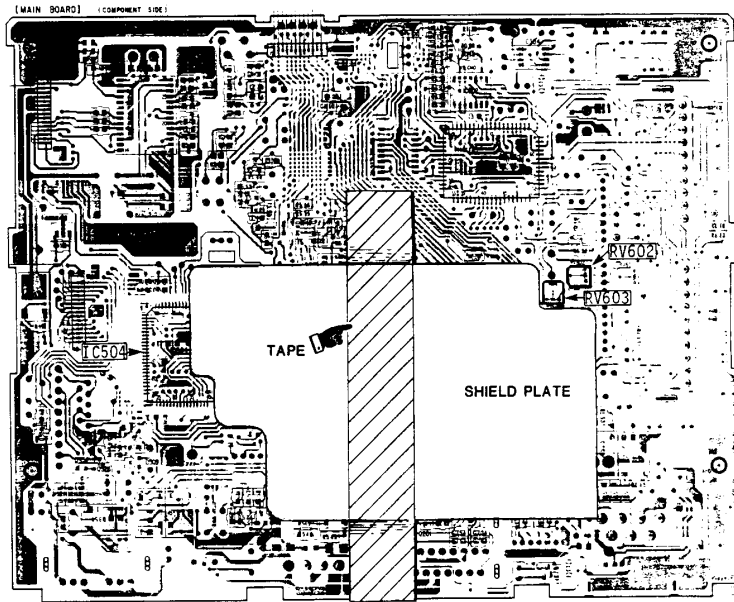
A ticking noise may be heard from the speakers while listening to quiet passages on the disc, or when between tracks.

Add a shield plate to the Main Board as shown below. Secure the shield with tape:

DESCRIPTION	PART NUMBER
SHIELD PLATE	T-9985-491-1
