# Car Stereo Service Bulletin

**Model:** EXR-25; XR-4257/4357

**No.** 252

**Subject:** Tuner Pre-sets Are Lost Or "SDK" Appears  
On The Display

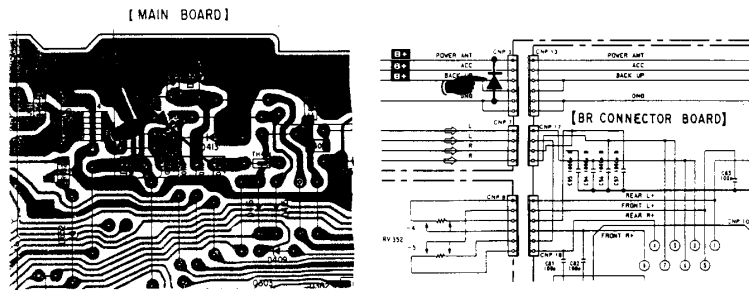
## EXR-25

Tuner pre-sets are lost when power antenna is activated, or when unit is removed from the mounting sleeve. In some instances, "SDK" appears on the display.

- Solution:**
1. Add a 10K $\Omega$  resistor in parallel with C-411 on the main board (XR-4257 only).
  2. Add an 11ES2 diode to the power antenna circuit (REM out) on the Main MCB.
