**SONY** Car Stereo  
**Service Bulletin**

**Model:** XR-U220/U330

**No. 300**

**Subject:** Availability Of Extension Cable.

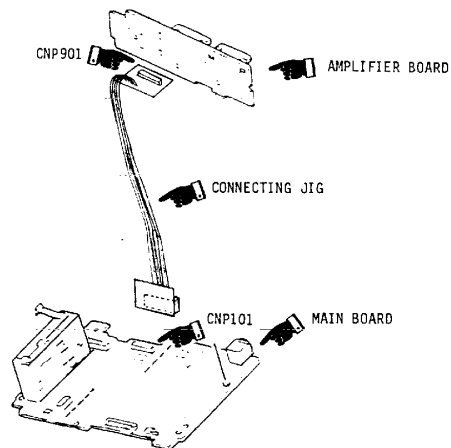
Please note that the red wire of the cable should connect pin 1 (TEL MUTE) of CNP901 with pin 1 (TEL MUTE) of CNP101.

**Solution:** An extension cable may be ordered from the National Parts Center as follows:

REF	DESCRIPTION	PART NUMBER
	EXTENSION CABLE, MAIN BOARD TO AMP BOARD	J-2502-005-3
