Car Stereo
Service Bulletin

Model: XR-3050

No. 301

Subject: Schematic Error, Q701 and Q706

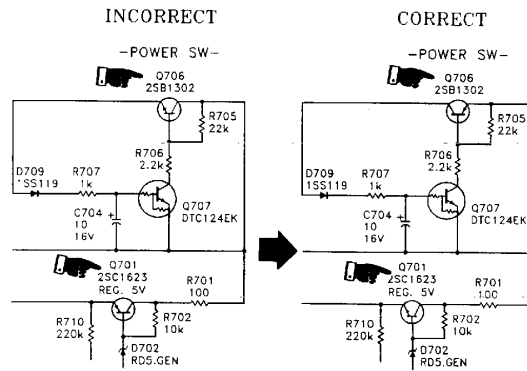
The schematic incorrectly shows Q701 as PNP type, while in fact it is NPN type.
Also, the schematic shows Q706 as NPN type, while in fact it is PNP type.

Please correct your service manual as shown below.
