# Car Stereo Service Bulletin

**Model:** XR-U500/U700/U800

**No.** 343

**Subject:** Switching Noise Heard From Speakers While  
Volume Is Being Increased Or Decreased.

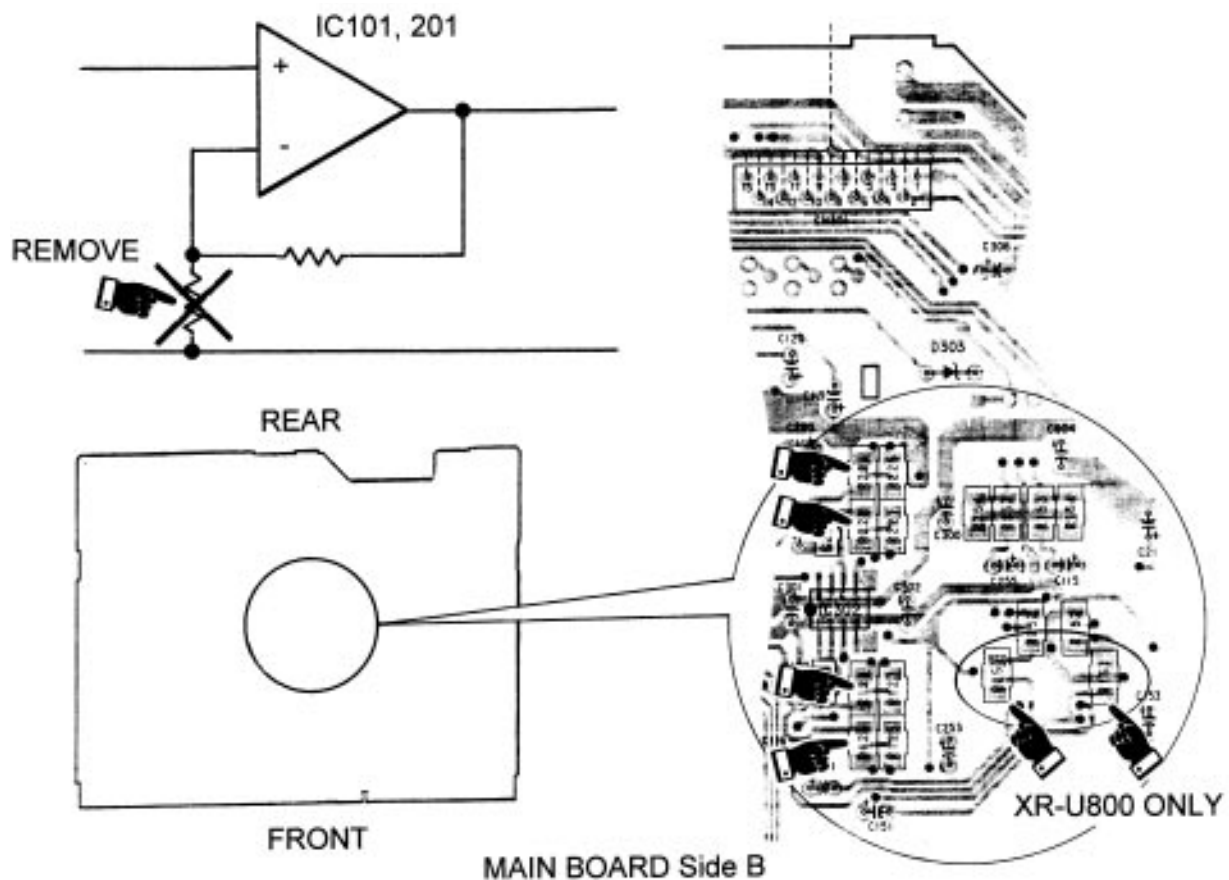
Switching noise may be heard from the speakers while the volume level is being increased or decreased. The noise is particularly noticeable when high power amplifiers or high efficiency speakers are connected to the unit.

If the customer complains of this problem, remove R126, R128, R226, and R228 from the Main board. On XR-U800, also remove R151 and R251.
