Hi-Fi Products
Service Bulletin

Model: D-15

No. 39

Subject: Portable Disc Player

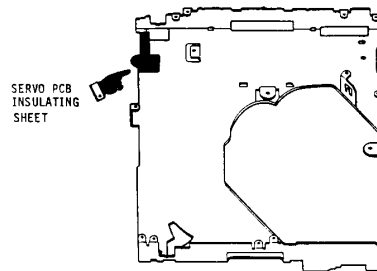
PCB shorts to the chassis.

Please add an insulating sheet to the servo PCB as shown.

Description	Part Number
Servo PCB Insulating Sheet	4-926-105-01
