Hi-Fi Products  
**Service Bulletin**

**Model:** MHC-1500, FH-B7CD, FH-B5CD

**No.137**

**Subject:** CD No Operation

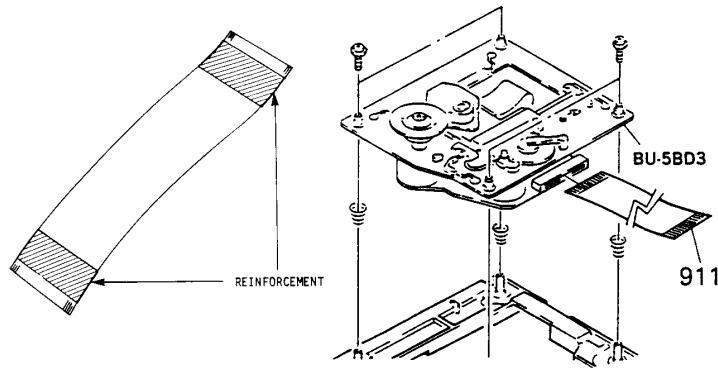
If the CD is non-operational, it is caused by the flexible board with the terminal (between the BD Board and the Main Board) being disconnected.

**Solution:** Replace the flexible board with the new one which has been reinforced.

Ref. No.	Description	Part Number	
		Former	New
911	Flexible Board With Terminal	1-535-832-11	1-535-832-12
