Hi-Fi Products
Service Bulletin

Model: DTC-75ES/700

No.160

Subject: No Loading, No Eject

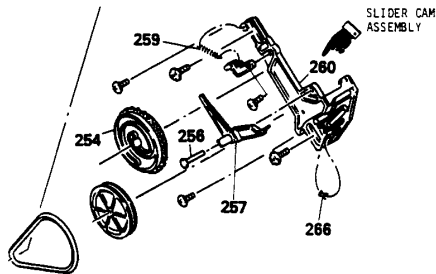
Cassette cannot be loaded or ejected. Slider Cam breaks when cassette is forcibly loaded.

Solution: If this symptom occurs, replace Slider Cam with improved Slider Assembly.

Description	Part Number
Slider Assembly	X-3362-656-1
