Hi-Fi Products
Service Bulletin

Model: SRS-D3K

No. 163

Subject: Hum During Silence

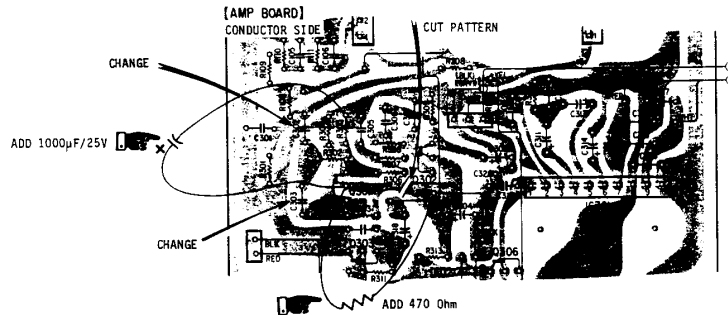
Symptom:
(54)

Hum may be heard during passages of silence when listener is positioned close to speaker, and ambient room noise level is very low.

Solution: If this symptom occurs, make the following changes to the "AMP" Board:

CHANGE

Ref. No.	Description		Part Number	
	Former	New	Former	New
C302	Capacitor, 0.12uF, Mylar	Capacitor, 0.1uF, Tantalum	1-130-496-00	1-131-402-00
C303	Capacitor, 0.1uF, Mylar	Capacitor, 0.1uF, Tantalum	1-130-495-00	1-131-402-00

ADD

Description	Part Number
Resistor, 470 Ohm, 1/6W, Carbon	1-249-413-11
Capacitor, 1000uF/25V, Electrolytic	1-124-557-11
