Hi-Fi Products
Service Bulletin

Model: TA-DL100

No. 191

Subject: Incorrect Labeling of IC203/IC204 **Date:** May 8, 1991

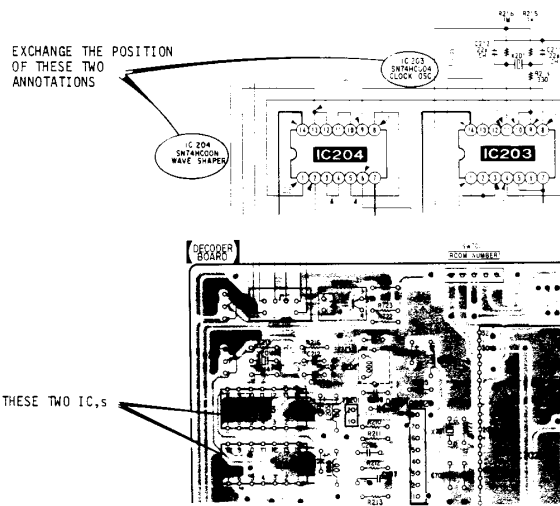
[DECODER BOARD]

The service manual (schematic diagram, physical diagram, and parts listing) has IC203 of the Decoder board listed as the clock oscillator (SN74HCU04) and IC204 as the wave shaper (SN74H00N).

Solution: Change the schematic, physical diagrams, and the parts list to show IC203 as the wave shaper and IC204 as the Clock Oscillator.
