Hi-Fi Products
Service Bulletin

Model: STR-AV500

No. 230

Subject: Unidentified Components Found On Main PCB -
Capacitor and Diode

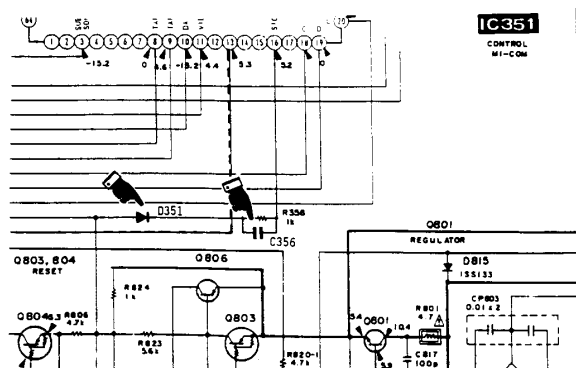
Several components have been put on the Main board that are not found on the schematic diagram and no change has been made to the Main PCB part number.

Please add the following components to your schematic diagram.

REF. NO.	DESCRIPTION	PART NO.
C356	.022 μ F	1-161-055-00
D351	1SS133	8-719-901-33
