Hi-Fi Products
Service Bulletin

Model: MDR-IF5K

No. 254

Subject: Charged Battery Does Not Last

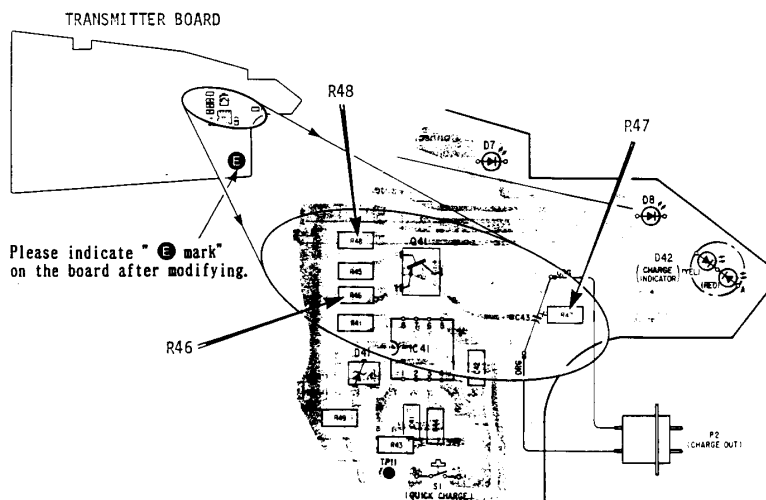
The battery only lasts two hours after repeated 3 hours quick charge.

Solution: Replace the chip resistors on TX Board with the following:

REFERENCE	DESCRIPTION		PART NUMBER
	FORMER	NEW	
R46	150 OHMS	100 OHMS	1-216-174-00
R47	100 OHMS	0 OHMS	1-216-296-00
R48	3.9 OHMS	1.5K	1-216-202-00
