Hi-Fi Products
Service Bulletin

Model: D-802K

No. 256

Subject: No Power When Using AC Adaptor

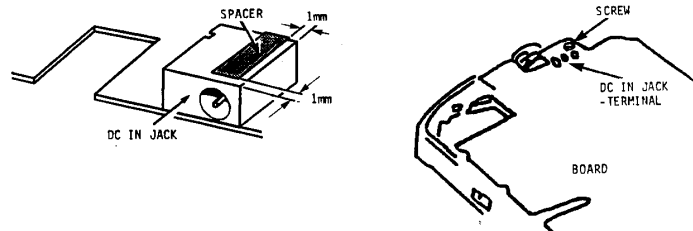
Symptom:
(11) No power when using AC adaptor.

Solution: Attach a spacer on the DC in jack as shown below. Be sure to attach it at 1mm from the CD in jack edges.

DESCRIPTION	PART NUMBER
SPACER (VOL)	3-376-165-01

After refitting the board with the screw, remove the solder at the DC in jack terminal to loosen the jack; then reposition the jack so that it touches the board without having any play between the DC in jack and the chassis. Afterwards, resolder the terminal.
