Hi-Fi Products
Service Bulletin

Model: MHC-2600/3600, ST-H3600

No. 267

Subject: Clock Accuracy

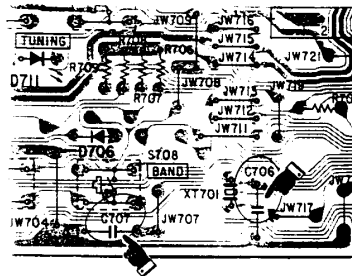
Symptom: (23) The clock is too slow and loses some seconds each day.

Solution: Change the value of C706 and C707 on the display board according to the following table:

REF. NO.	DESCRIPTION		PART NUMBER
	FORMER	NEW	
C706/707	15pF/50V	5.6 pF/50V	1-162-196-31
