Hi-Fi Products Service Bulletin

Model: CDP-X779ES

No. 288

Subject: Balanced Outputs in Reverse Phase

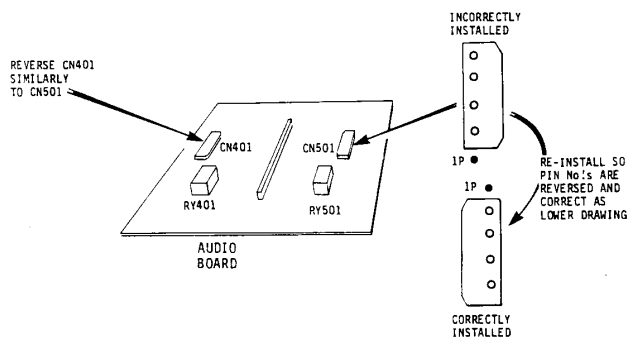
The phase on the balanced outputs is in reverse due to incorrectly installed connectors. CN501 and CN401 on the audio board have been mounted in reverse.

Remove CN501 (RED) and CN401 (BEIGE) from the audio board and install them in reverse order (see drawing below):
