Hi-Fi Products
Service Bulletin

Model: STR-AV910/AV920/AV970X/AV1010/
AV1020/AV1070X

No. 291

Subject: RTA Display Jumps When Changing Volume
Level With Remote Commander

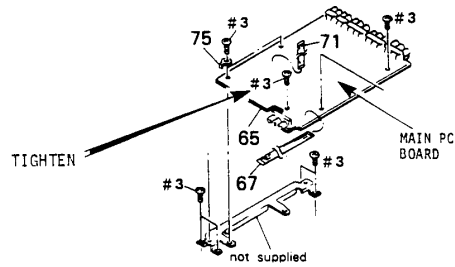
The levels on the RTA display jump when no signal is present and the volume level is changed using the remote commander. Changing the volume level by operating the master volume control manually does not affect the RTA display.

Tighten the ground screw located at the front right side of the main PC board (as viewed from the front of the unit).
