Hi-Fi Products
Service Bulletin

Model: D-311

No. 313

Subject: Discs Do Not Play.

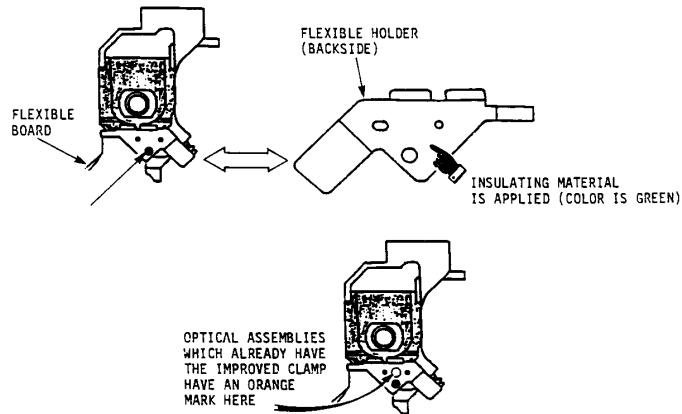
The PD signal lead of the flex cable shorts to the clamp which secures the flex cable to the optical assembly. This prevents the disc from playing.

Note: Some optical assemblies have been manufactured with the improved clamp. These assemblies can be identified by an orange mark on the clamp.

Solution: Replace the clamp with an improved type.

REF	DESCRIPTION	PART NUMBER
-	FLEX CABLE HOLDER	2-625-775-03
