Hi-Fi Products  
**Service Bulletin**

**Model:** TC-818M, MHC-3300CD

**No.** 321

**Subject:** Clicking Noise

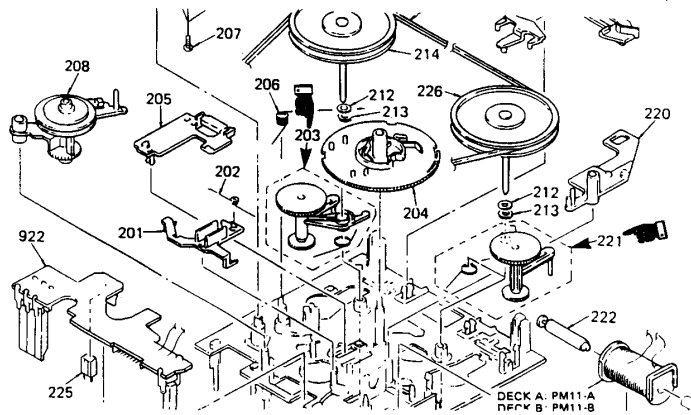
**Symptom:**  
(64) Clicking noise in either A or B Decks.

REF	DESCRIPTION	PART NUMBER
203	LEVER (TU ARM REV) ASSY	X-3343-406-1
221	LEVER (TU ARM FWD) ASSY	X-3343-405-1

**Solution:** Please change the following parts with the improved versions. (same part numbers).
