Hi-Fi Products
Service Bulletin

Model: TA-S7

No. 350

Subject: Video processed through the *Video In* input is washed out.

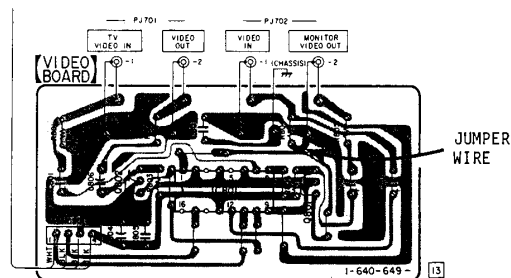
A video signal processed through the *Video In* input is washed out when observed through the *Video Out* output. When the same video signal is connected to the *TV Video In* input, the signal observed through the *Video Out* output looks normal.

Solution: One side of R804 is missing a connection to ground on the Video Board. The trace on one side of R804 does not connect anywhere. Connect the open side of R804 to the ground plane on the Video Board as shown in the diagram below.
