Hi-Fi Products
Service Bulletin

Model: D-311

No. 366R1

Subject: LCD Display Doesn't Function Properly.

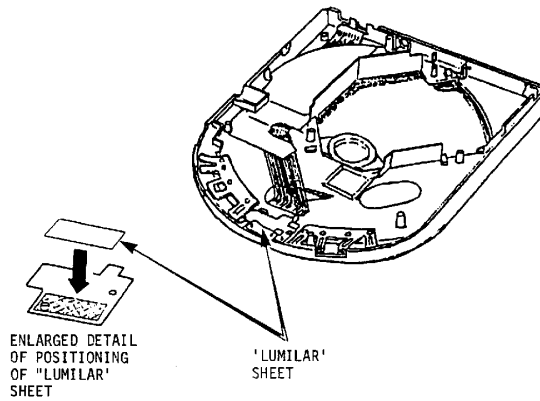
LCD display doesn't function properly.

1. Replace the damaged LCD flexible flat wire.
2. Stick a lumilar sheet on the point of screw that attaches the open button return spring to the upper panel.

REF	DESCRIPTION	PART NUMBER
-	LUMILAR SHEET	4-958-091-01
