Service Bulletin

Model: D-321

No. 368

Subject: During Battery power, When Battery's Voltage
Drops To A Low Level, Noise Is Heard

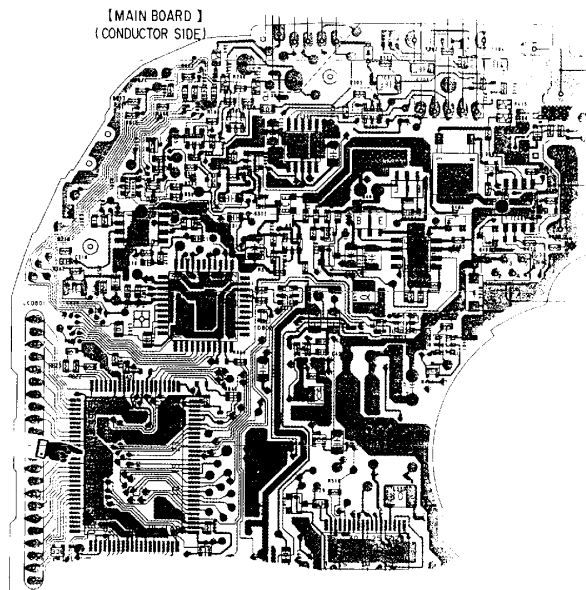
During battery power, when battery's voltage drops to a low level, noise is heard

Solution: replace IC801 to the part listed below.

REF	DESCRIPTION	PART NUMBER
IC801	IC CXP83916-610Q	8-752-851-84
