Service Bulletin

Model: D-121/125

No. 372

Subject: CD Not Locking - Reconnect CN501

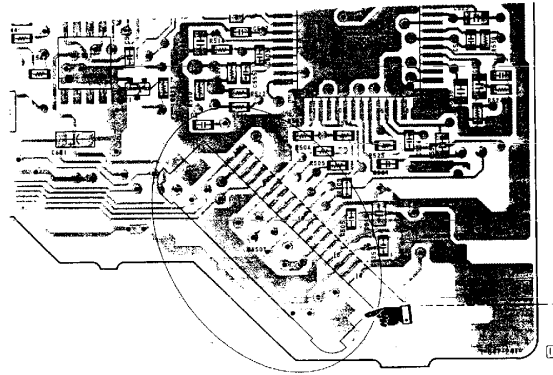
Unit would not read disc, indicating "No Disc" on display.

Solution: Reconnect connector CN501 onto Main Board.

REF	DESCRIPTION	PART NUMBER
CN501	CONNECTOR, FPC (ZIF) 18P	1-566-534-11
