Hi-Fi Products
Service Bulletin

Model: SA-VA3

No. 398

Subject: Fluorescent Display shuts off.
Serial numbers 823103 - 823918

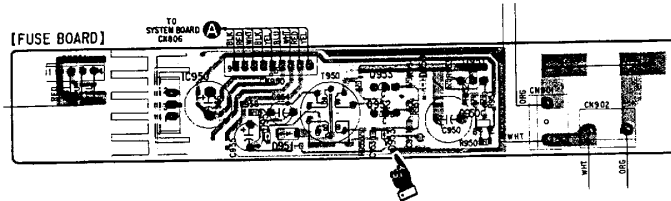
The fluorescent display FL801 will turn off in 3 to 5 minutes after the power is turned on

Add the missing diode, listed below, to the fuse board.

REF	DESCRIPTION	PART NUMBER
D953	DIODE, RD36S-B	8-719-158-82
