Hi-Fi Products Service Bulletin

Model: TC-WR445

No. 421

Subject: Mechanical noise in play mode

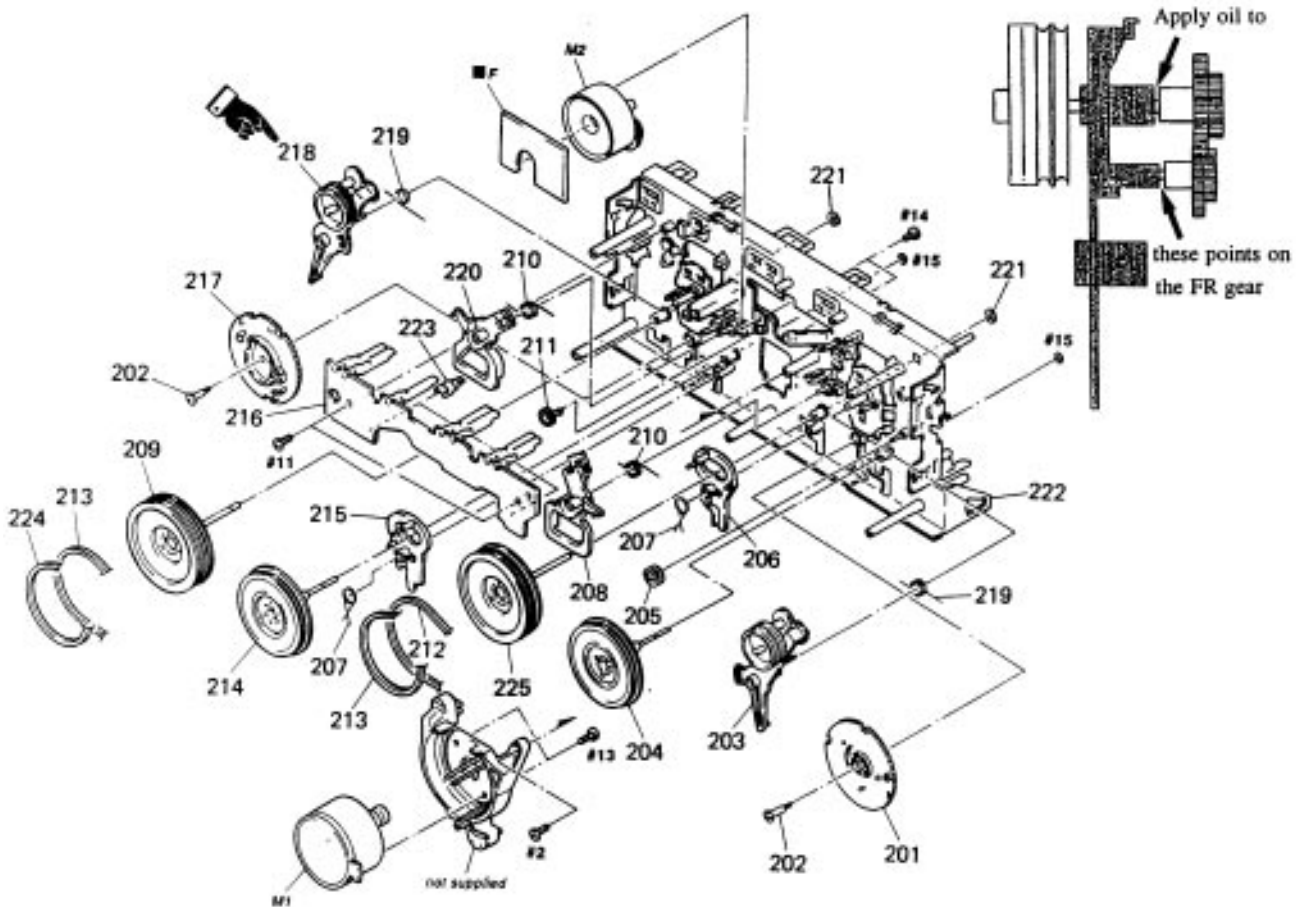
A loud mechanical noise may be heard while in the play mode. This is due to a lack of oil on the FR gear.

Apply a few drops of Sony oil, P/N 7-661-018-18, to the shaft of the FR gear. See diagram below.
