# Hi-Fi Products Service Bulletin

**Model:** SS-U241

**No.** 424

**Subject:** Removal and re-assembly of Speaker Grille

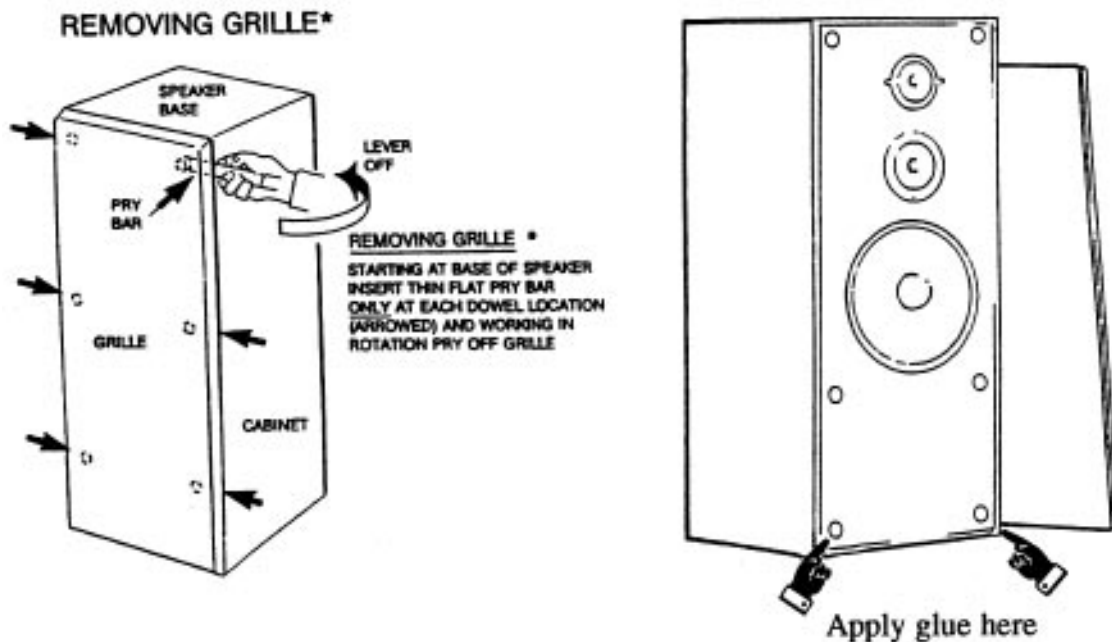
Due to a temporary production change, the SS-U241 speakers manufactured in October and November of 1994 had the speaker grilles secured at the bottom two holes using Hot Melt glue. The applicable Serial Number range for this procedure is 8044738 ~ 8058376.

To service this speaker, pry the grille off as instructed in the Service Manual (see below). When the repair has been completed, re-attach the grill using a water based white glue to secure the bottom two holes.
