# Hi-Fi Products Service Bulletin

**Model:** DTC-57ES/670/750

**No.** 427

**Subject:** Replace T2 guide when replacing Chassis assy

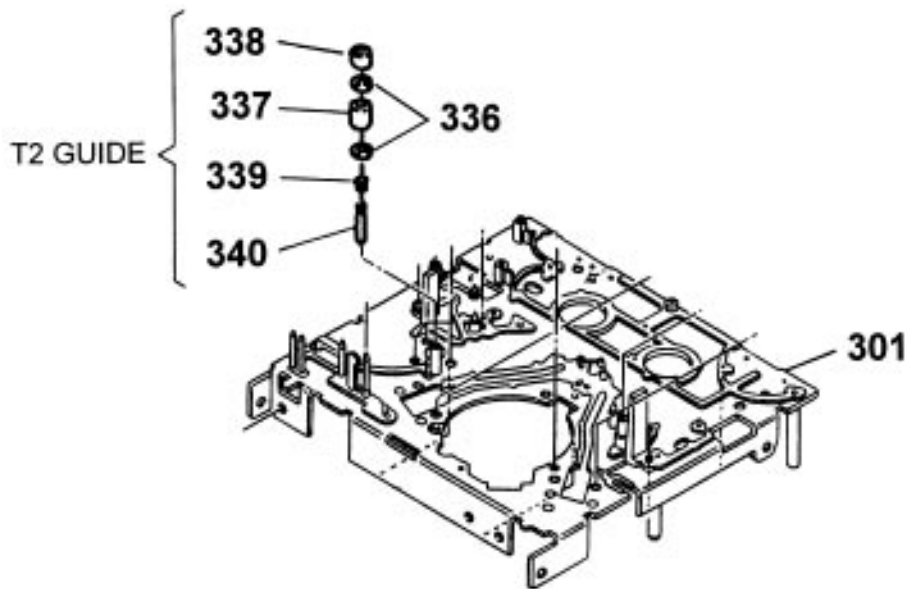
When a new chassis assembly is installed (P/N X-3366-740-1) the original T2 guide will not fit the opening of the improved chassis.

**Solution:** Assemble and install the new T2 guide using the parts listed below.
