Hi-Fi Products Service Bulletin

Model: MHC GENERAL

No. 434

Subject: Static Noise during Playback

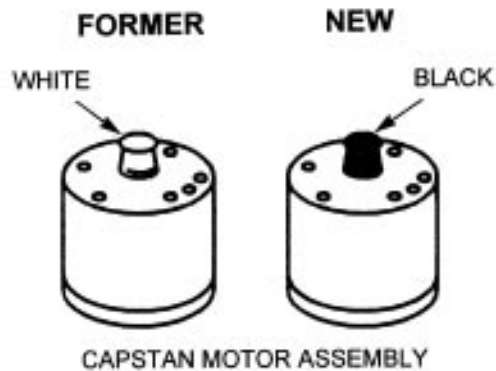
(**) A static noise is heard when playing back a tape.

Solution: Replace the motor assembly (capstan) as listed below.
