Hi-Fi Products Service Bulletin

Model: CDP-C445

No. 465

Subject: Drawer will not open

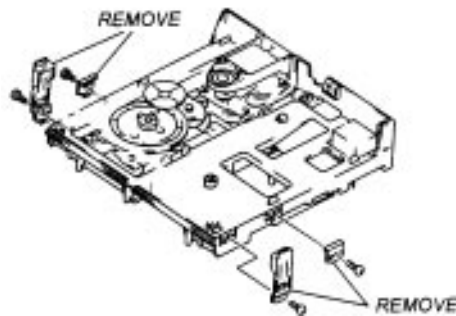
(**) The Drawer will not open or open completely.

Remove the four screws holding the cabinet top. Lift the cover off of the unit. Remove the two large brackets located at the front of the unit. Remove the small brackets (see diagram).
