Hi-Fi Products

Service Bulletin

Model: TCD-D3

Subject: Identifying New Loading Gear

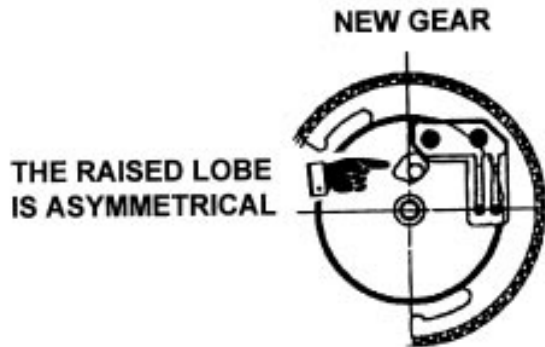
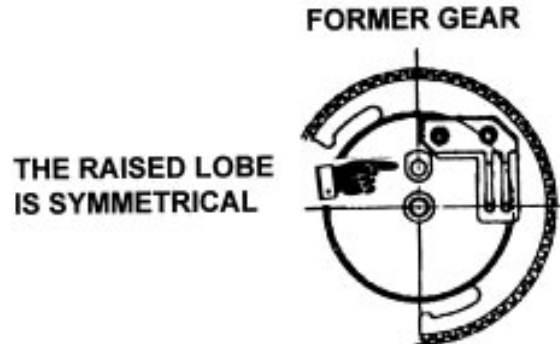
HOW TO DISTINGUISH:

The shape of the sub chassis has been changed therefore, two different types of loading gears are registered. The two types of loading gears cannot be interchanged. If the wrong type of gear is installed, gear noise would occur due to incomplete rotation.

When replacing the loading gear use the same style of gear that was removed. Use the drawing below to identify the two types of loading gear assemblies.

The part numbers for the New and Former loading gears are listed below.

REF	FORMER		NEW	
	DESCRIPTION	PART NUMBER	DESCRIPTION	PART NUMBER
307	ORIGINAL LOADING GEAR	X-3344967-6	NEW LOADING GEAR	X-4944-064-1
