# Hi-Fi Products Service Bulletin

**Model:** STR-GX700ES

**No.** 468

**Subject:** Unit goes into Protection when Powered On

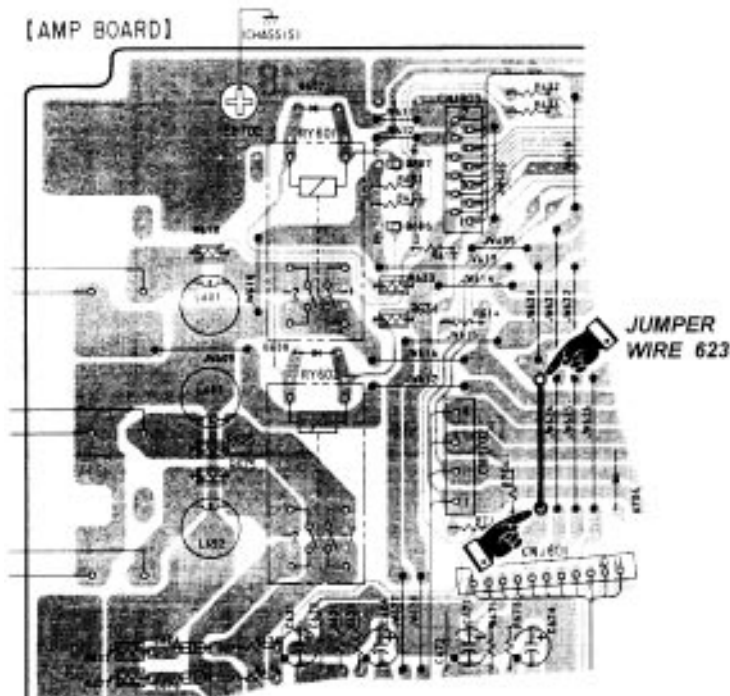
(\*\*) The unit will go into protection when it is powered on.

**Solution:** Add missing jumper wire, JW623 on the Amp Board. The See diagram below
