Model: CDP-CX250**No.** 499**Subject:** Display is too dark or does not light**Date:** November 8, 1996**Symptom:**

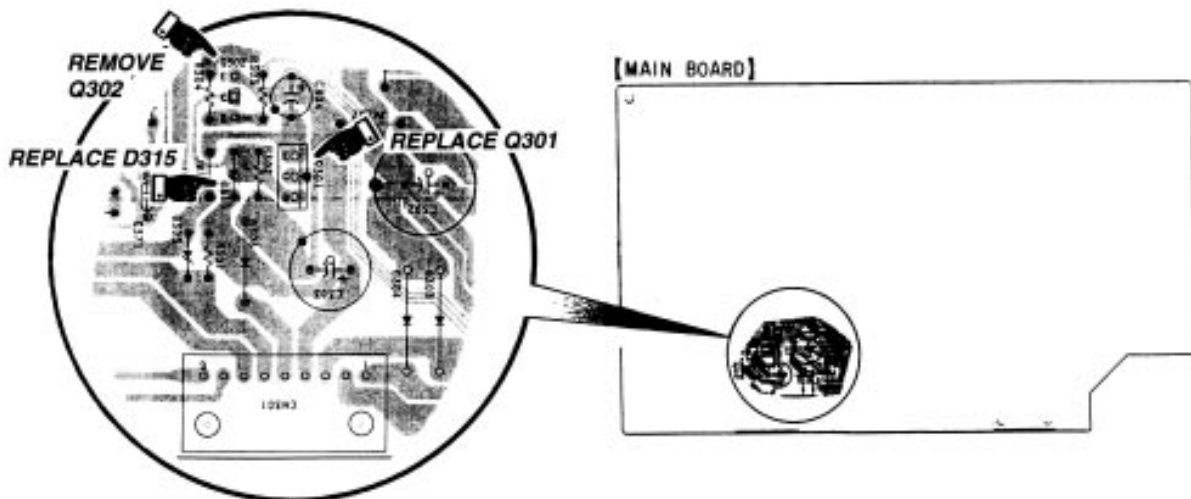
() The customer states the display is too dark to read or it does not light at all.

Solution: Replace or remove parts as listed below (see diagram for parts location).

REF#	DESCRIPTION	PART NO	ACTION
Q301	2SB734	8-729-140-97	REPLACE
D315	RD30ESB2	8-719-110-72	REPLACE
Q302	2SA1175	8-729-119-76	REMOVE
