Model: MZ-E3

No. 511

Subject: Display Only, No Operation

Date: January 30, 1997

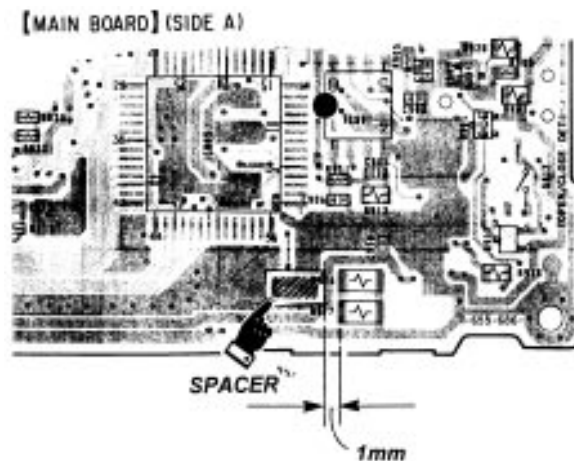
FIG.1

- I. Replace the sled motor
- II. Replace the inductors with those identified in the table
- III. Add spacer as shown in Fig 1.

REF	FORMER		NEW	
	DESCRIPTION	PART NUMBER	DESCRIPTION	PART NUMBER
M902	SLED MOTOR	1-698-315-11		
L503, 507, 509 515, 516 801	INDUCTOR 47H	1-414-402-11		1-412-031-11
ADD			SPACER (3X3)	4-984-119-01
