Model: D-211

No. 514

Subject: IC 504 (PWM Driver) No Longer Available.

Date: January 30, 1997

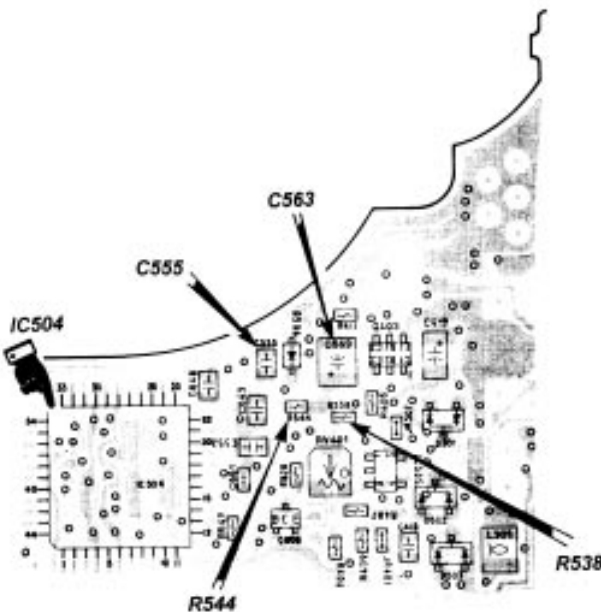
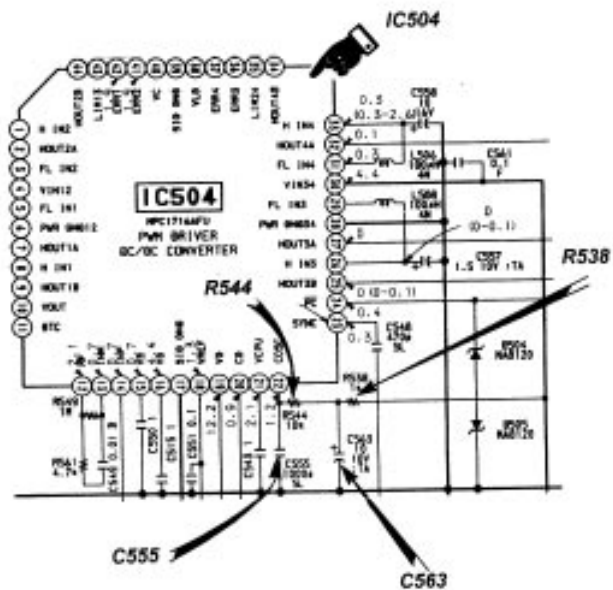
(***) The PWM driver is no longer available

When replacing the IC, use the chip defined below. Make sure to remove and /or replace the additional components identified.

REF	FORMER		NEW	
	DESCRIPTION	PART NUMBER	DESCRIPTION	PART NUMBER
IC504	MPC1716FU	8-759-039-13	MPC1718FU	8-759-084-72
R538	1K OHM 1/16W	1-216-821-11	REMOVE	
R544	10K OHM 1/16W	1-216-833-11	REMOVE	
C563	10UF 10V	1-135-216-11	REMOVE	
C555	.001UF 50V	1-163-141-00	820PF CHIP	1-163-139-00
