SONY car stereo

Service Bulletin No.57

Model: XR-15

Subject: Service Manual Correction,
Front-End Block Wiring

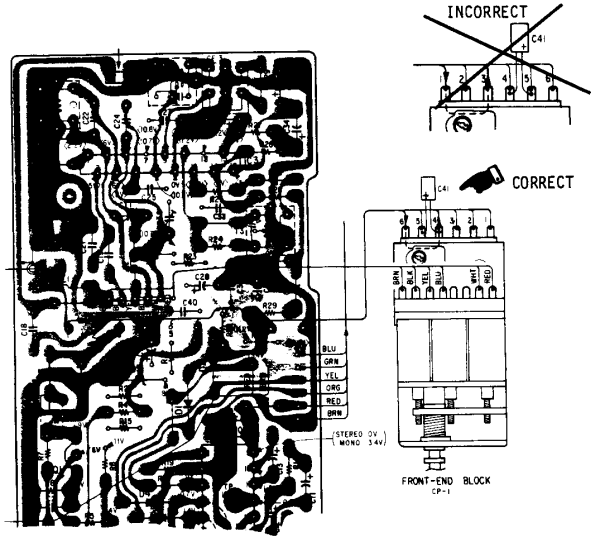
Note the correct wiring diagram for the front-end block on page 16 of the service manual.
